ARMY CONCEPT TEAM IN VIETNAM
APO 143, San Francisco, California

Mechanized Rifle Troop
(M113) (U).

INTERIM TEST REPORT NUMBER 8

1-30 September 1963.

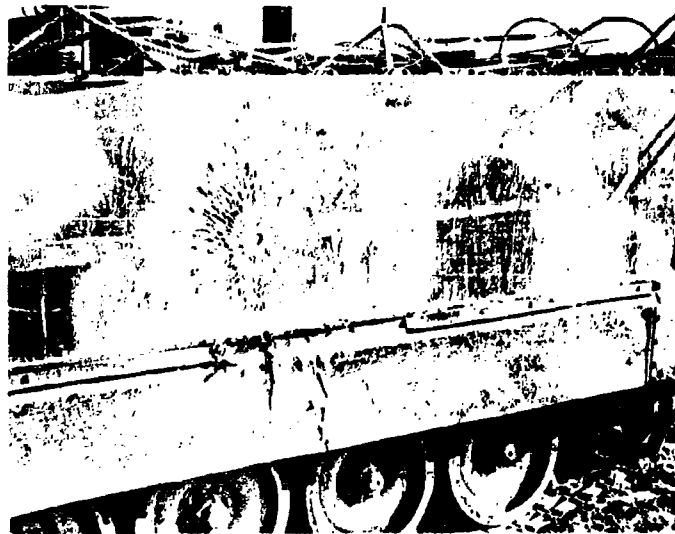
The second carrier was hit in the left side by a 57mm HEAT round. (See Figures 13 and 14.) This round penetrated the carrier and killed one man.

FIGURE 13 (C)
Effect of 57mm HEAT round.

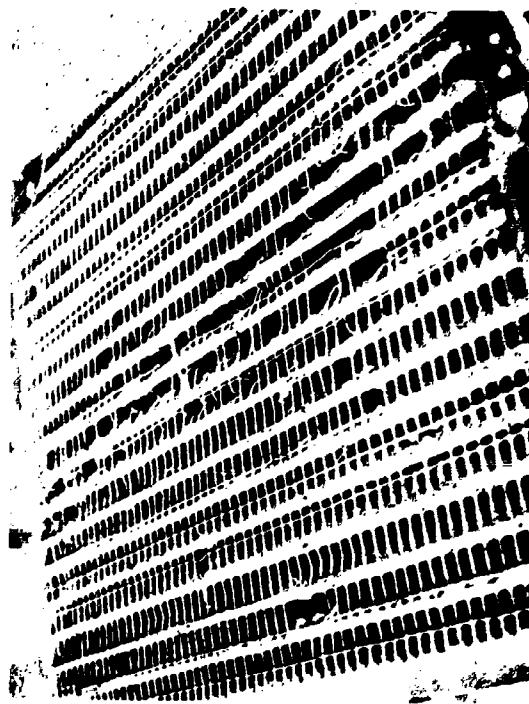
FIGURE 27 (C)
Effects of a rifle grenade on the intake grill.

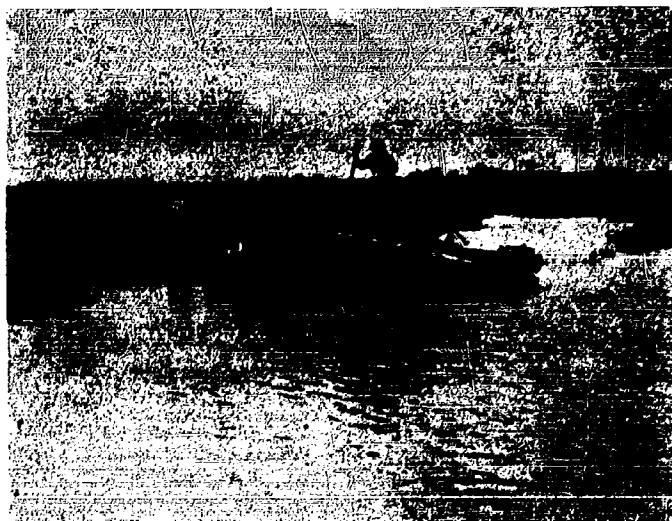
FIGURE 34 (U)
M113 cannot exit from the canal unassisted.
